BOUNDARY & IMPROVEMENT SURVEY

A PORTION OF BLOCK 173, WEST KING TRACT
SECTION 28, TOWNSHIP 2 SOUTH, RANGE 30 WEST
CITY OF PENSACOLA, ESCAMBIA COUNTY, FLORIDA

PPM Consultants, Inc. (PPM) was retained by the City of Pensacola to conduct a Phase I Environmental Site Assessment (ESA) of the Pensacola Motor Lodge (the subject property) located at 2305 West Cervantes Street in Pensacola, Florida. The purpose of this assessment was to identify recognized environmental conditions (REC) in connection with the subject property by means of interviews, review of record information, and site reconnaissance. The environmental assessment was conducted in conformance with the scope of ASTM International Standard Practice E1527-21.

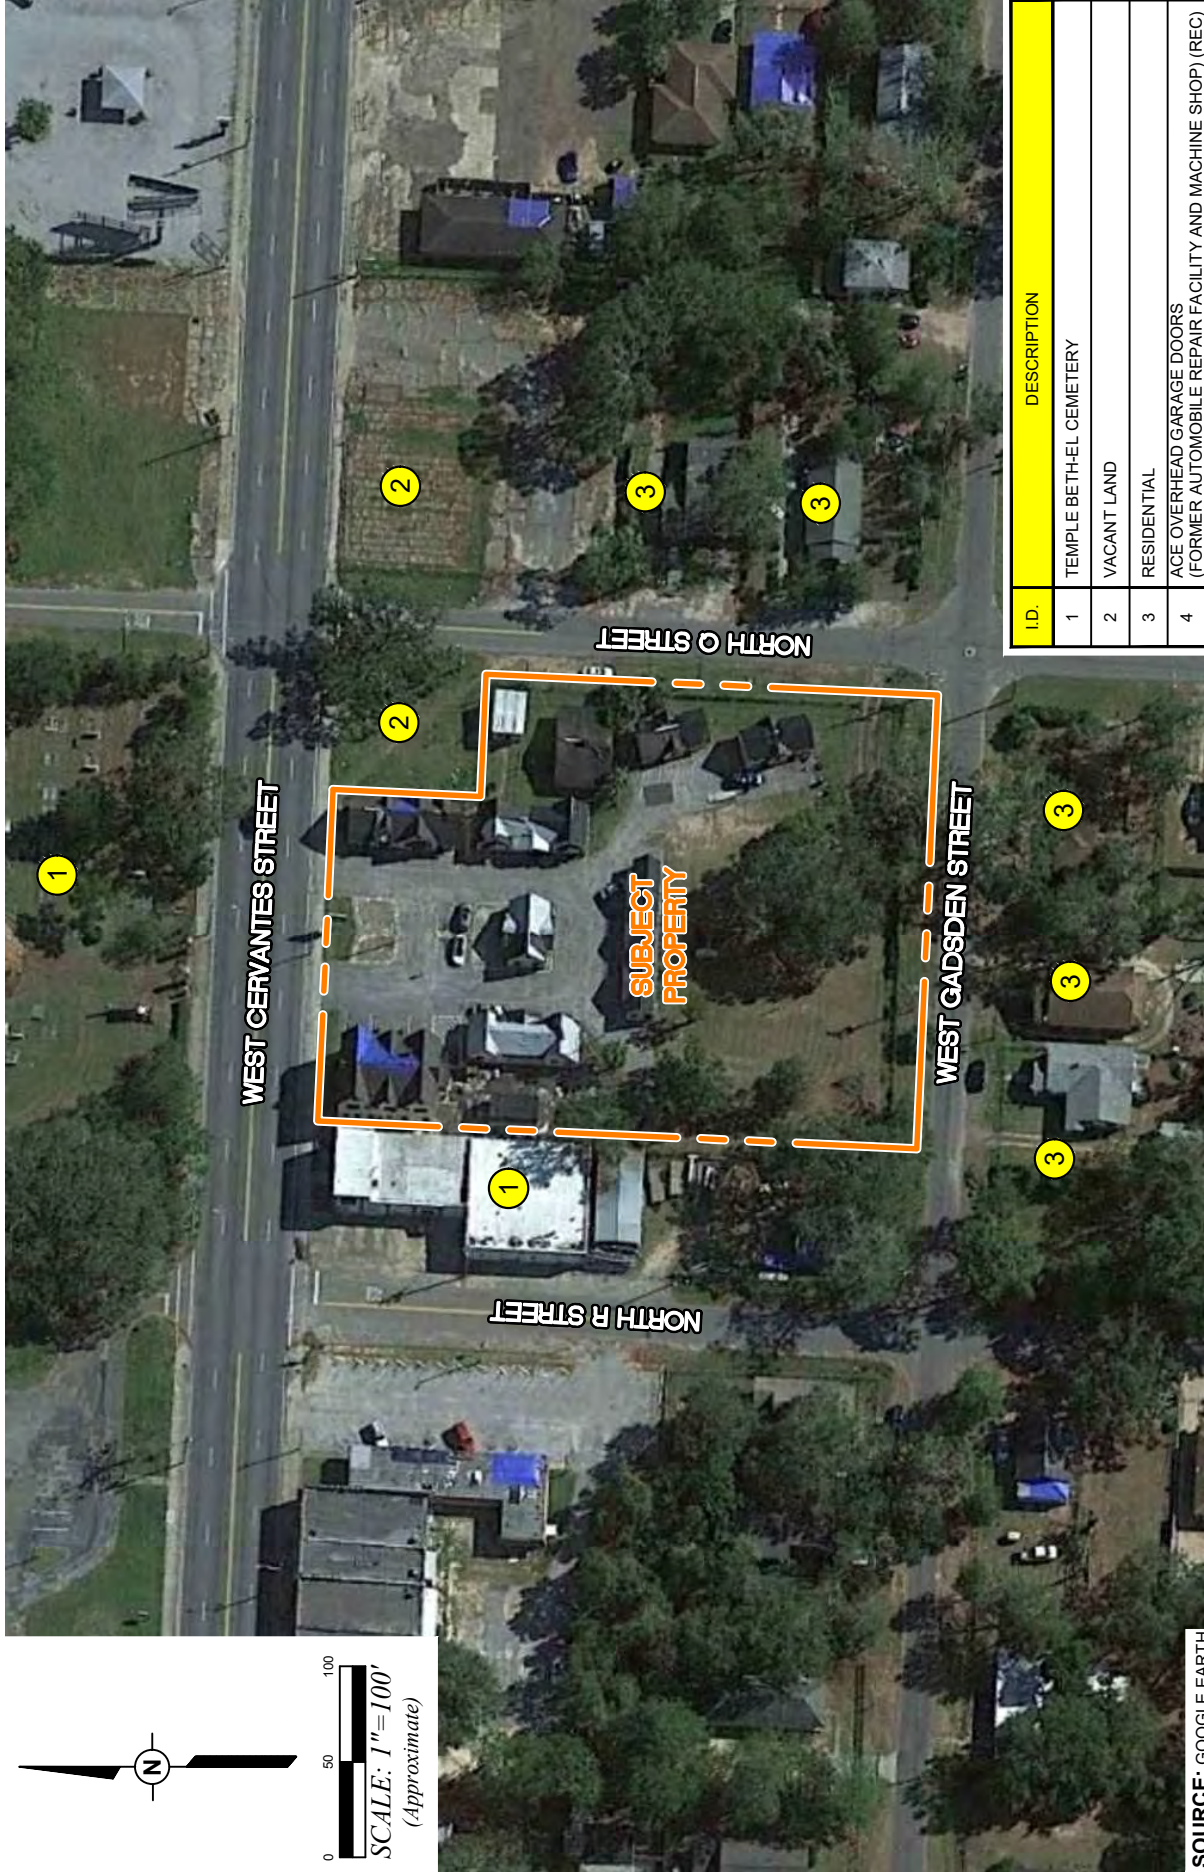
I.D.	DESCRIPTION
1	TEMPLE BETHEL CEMETERY
2	VACANT LAND
3	RESIDENTIAL
4	ACE OVERHEAD GARAGE DOORS (FORMER AUTOMOBILE REPAIR FACILITY AND MACHINE SHOP) (REC.)

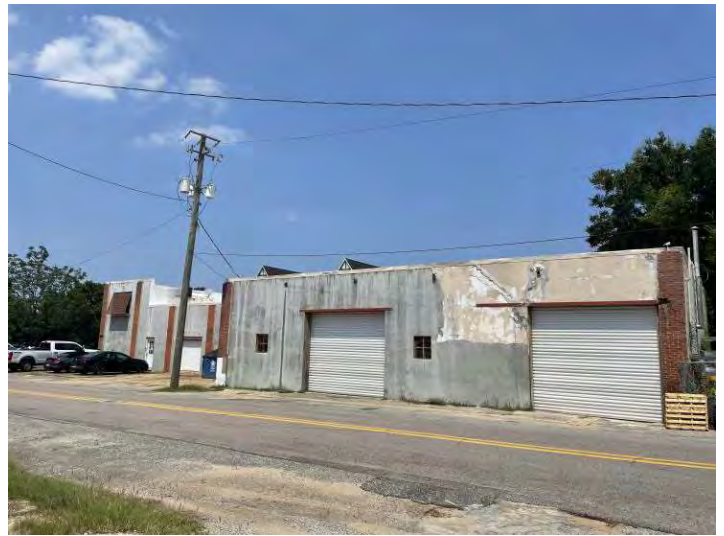
PHOTOGRAPH 26

- **Automobile repair facilities on an adjoining property.** An automobile repair facility and machine shop (Trawick Auto Repair and Trawick Machine Shop) were located on the adjoining property to the west from at least 1940 to at least 1979 and from at least 1988 to at least 2012. The chemicals of concern are hazardous materials and petroleum products, such as antifreeze, oil, cleaners, gasoline, solvents, degreasers, etc. The media of concern is soil, groundwater, and soil vapor. This condition is a REC.

View of Ace Overhead Garage Doors (former Trawick Automobile Repair and Trawick Machine Shop) on the adjoining property to the west, facing east-northeast.

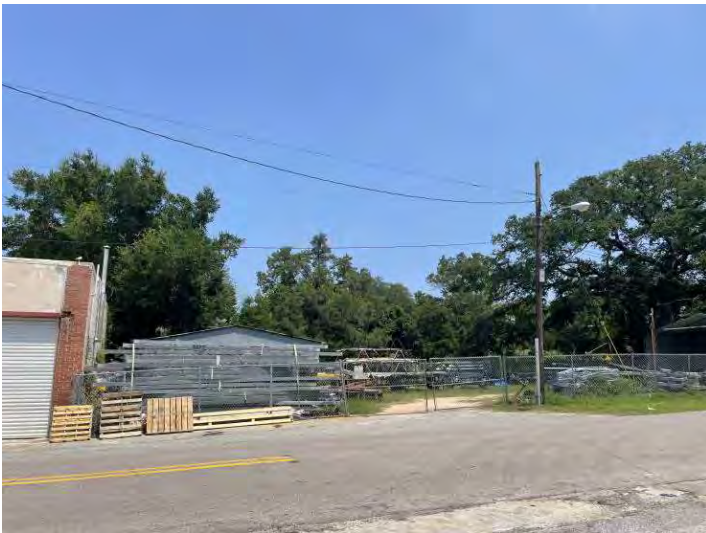
PHOTOGRAPH 27

View of Ace Overhead Garage Doors (former Trawick Automobile Repair and Trawick Machine Shop) on the adjoining property to the west, facing east.

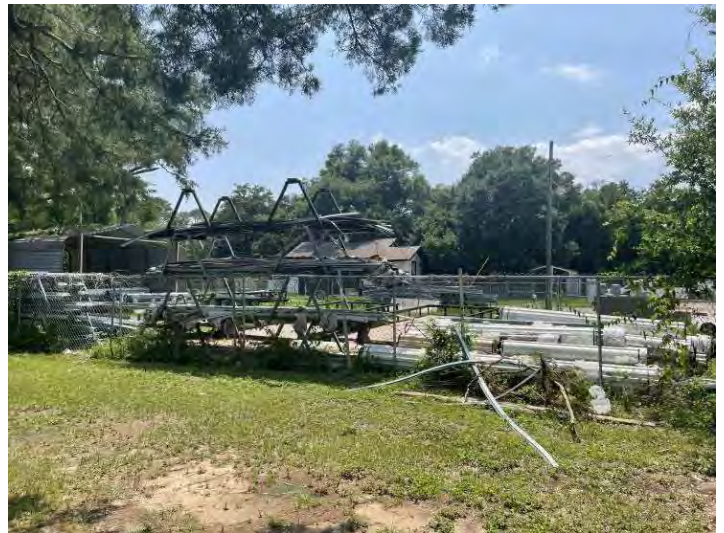
PHOTOGRAPH 28

View of Ace Overhead Garage Doors (former Trawick Automobile Repair and Trawick Machine Shop) on the adjoining property to the west, facing southwest.

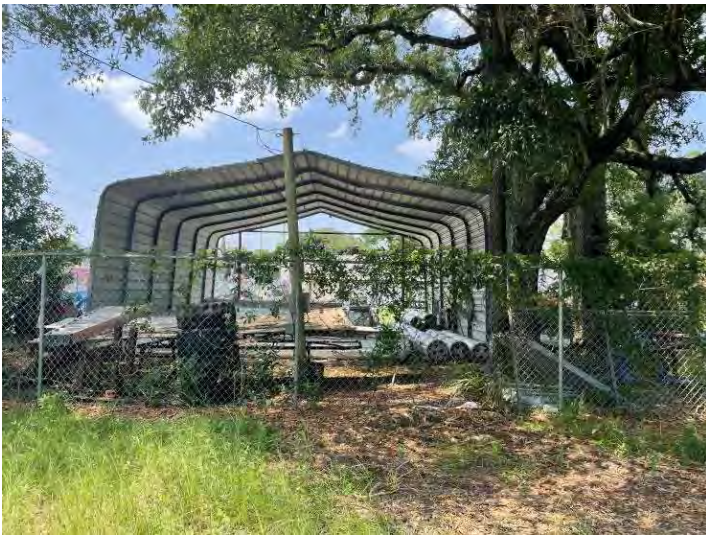
PHOTOGRAPH 29

View of Ace Overhead Garage Doors (former Trawick Automobile Repair and Trawick Machine Shop) on the adjoining property to the west, facing north.

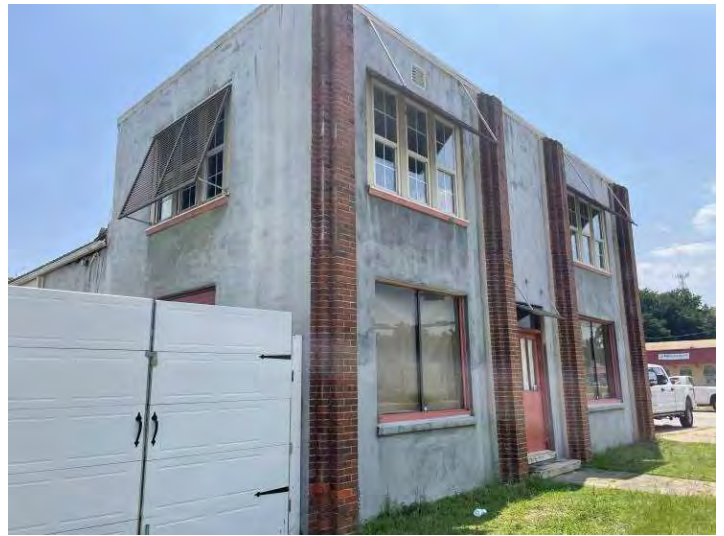
PHOTOGRAPH 30

View of Ace Overhead Garage Doors (former Trawick Automobile Repair and Trawick Machine Shop) on the adjoining property to the west, facing southwest.
